Technical Field Survey Report

Report X-20XX
Contract no. 123456

| Report reference | FS230XX | Accompanied by: | NA |

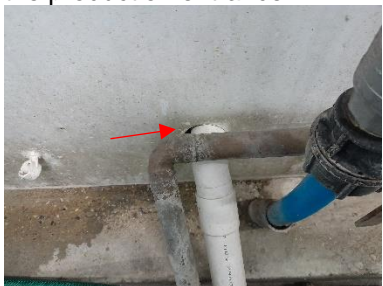
| Area | Observation | Recommendation | Priority | Action by | Date & Signature |
|---|---|--|---|---|---|
| Production | <p>There is a gap around the waste pipe, by the hand wash next to the production entrance</p> | Please fill this gap with mastic, or similar, to limit possible pest movements and to avoid debris and water becoming trapped | Low | C | |

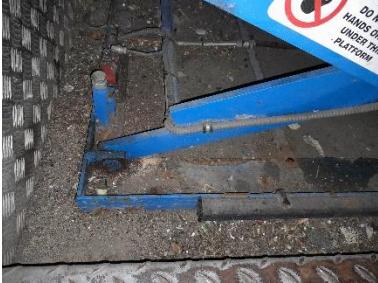
| Area | Observation | Recommendation | Priority | Action by | Date & Signature |
|---|---|--|---|---|---|
| Production | The void under the pallet lifter at the end of line 2 has an accumulation of debris and mouse droppings under it | Please clean this pit regularly to remove waste that is attracting pests and the droppings to help highlight any fresh activity Follow-up visits for the mouse activity are being conducted | High | C | |

Some signs of mouse activity found under the pallet riser in production. A mouse was removed from a nearby trap yesterday, so it is possible that these are now old: thorough cleaning of the area will help to confirm if the issue is now resolved, by highlighting any fresh droppings. Abate to conduct the next follow-up in 2 days. All other areas were clear and no activity noted externally.

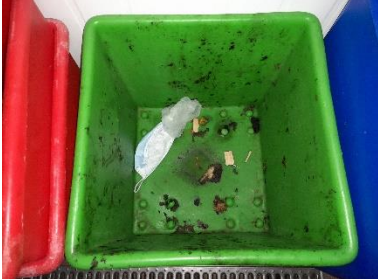
| Area | Observation | Recommendation | Priority | Action by | Date & Signature |
|---|--|---|---|---|---|
| Production – Chemical store | <p>A bin left in this room had some old product remains left in it</p> | <p>Please ensure that bins are clean before being put away into storage to avoid these remains attracting pests, especially fruit fly (<i>Drosophila spp</i>)</p> | Medium | Low | |

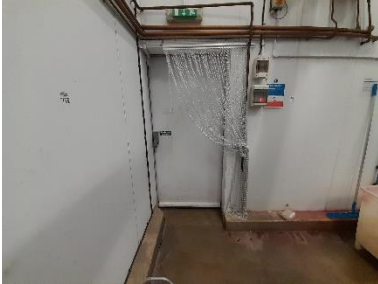
| Area | Observation | Recommendation | Priority | Action by | Date & Signature |
|---|--|---|---|---|---|
| Packing | <p>The chain curtain was tied open and has shifted to the RHS leaving a gap to the side of the curtain.</p> | <p>Please remind staff to keep the curtain in place</p> <p>Consider replacing this with a screen door – the door is often left open to help cool the area and a screen would allow cooling while reducing the risk of pest ingress. Abate can provide a quote for this work</p> | Low | C | |

Access is good – the access walkway around the goods in/out area is being maintained, thank you. Door discipline appeared good during the visit, although the packing room door curtain remains an issue, especially as the weather is starting to improve.

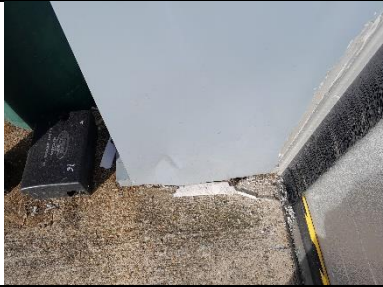
| Area | Observation | Recommendation | Priority | Action by | Date & Signature |
|---|--|---|---|---|---|
| Goods In/Out | <p>The roller shutter door has a gap under the LHS frame (photo taken from outside)</p> | <p>Please fill this gap to limit possible pest ingress – mastic may work for this gap</p> | High | C | |

General proofing is good, although the roller shutter door gap made a high priority given the previous mouse activity in this area.

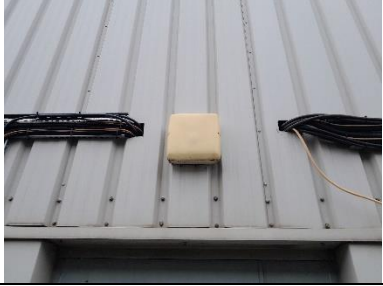
| Area | Observation | Recommendation | Priority | Action by | Date & Signature |
|---|--|--|---|---|---|
| External | There are gaps around the AC pipes above the side fire escape | Please fill these gaps to limit possible pest ingress – expanding foam may work although will need to be replaced with a more robust material in the event of rodent ingress | Low | C | |

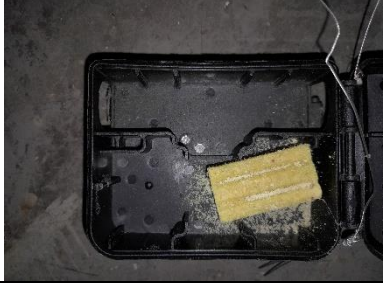
| Area | Observation | Recommendation | Priority | Action by | Date & Signature |
|---|--|---|---|---|---|
| Servicing | <p>Generally good but some of the baits did not appear to be that fresh, especially in the roof void</p> | Please replace baits regularly to avoid them becoming a potential breeding ground for insects | Medium | A | |
