Solar Panel Bird Proofing Case Study

September 2023

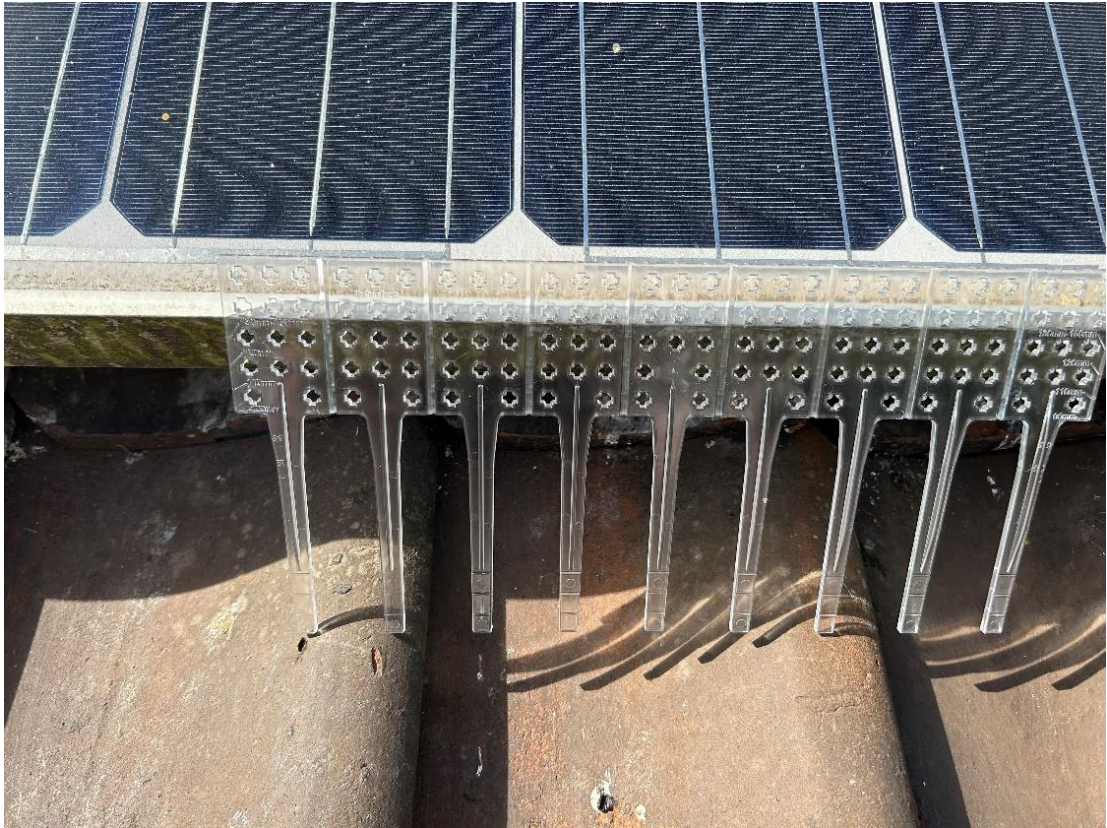
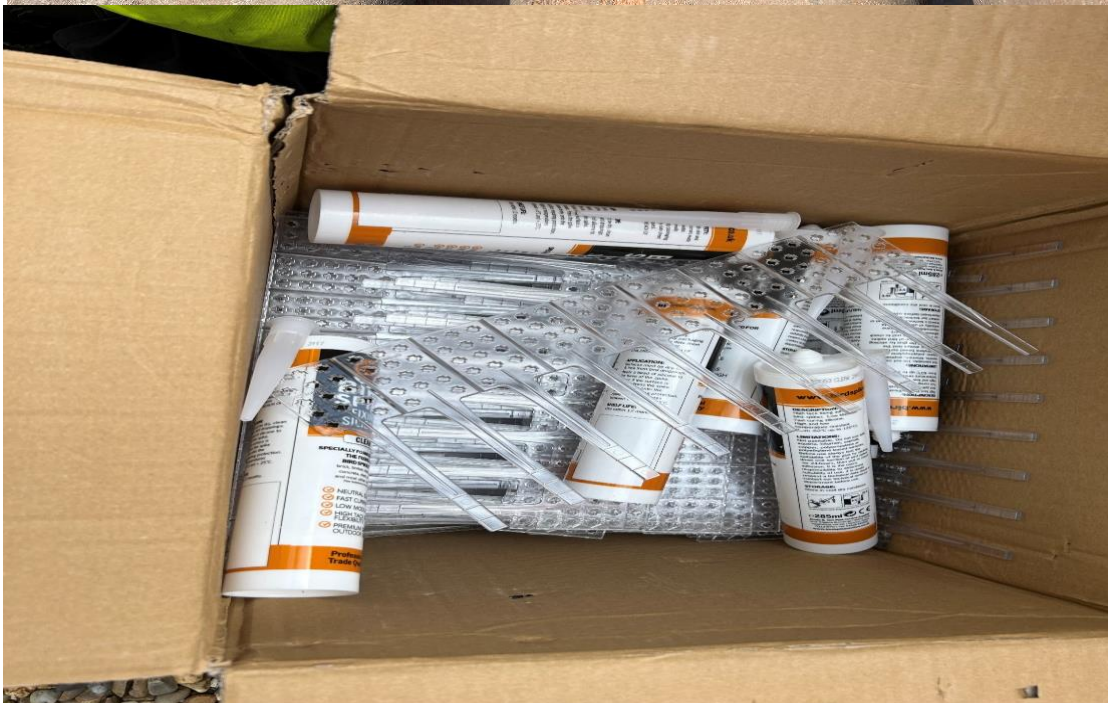
The homeowner had assumed the gaps under the panels being quite small, were too small for any large bird such as a pigeon to crawl under. However, it is very deceptive, especially when looking from the ground upwards – the gaps under the panels are almost perfect for pigeons and surprisingly easy for them to access.

Once under the panels, they feel safe, are protected from the elements, staying dry and warm too.

The circumference of the panels needed to be made inaccessible to the pigeons, and the whole area cleaned and sanitised too.

In this case, the best solution is a very strong plastic strip which can be cut to mirror the shape of each tile, thereby giving a very tight fit which is impossible for the birds to crawl under. Each strip is fixed with a clear adhesive to the outside of the panels, thereby never interfering with the panel's effectiveness, nor negating any guarantee either.

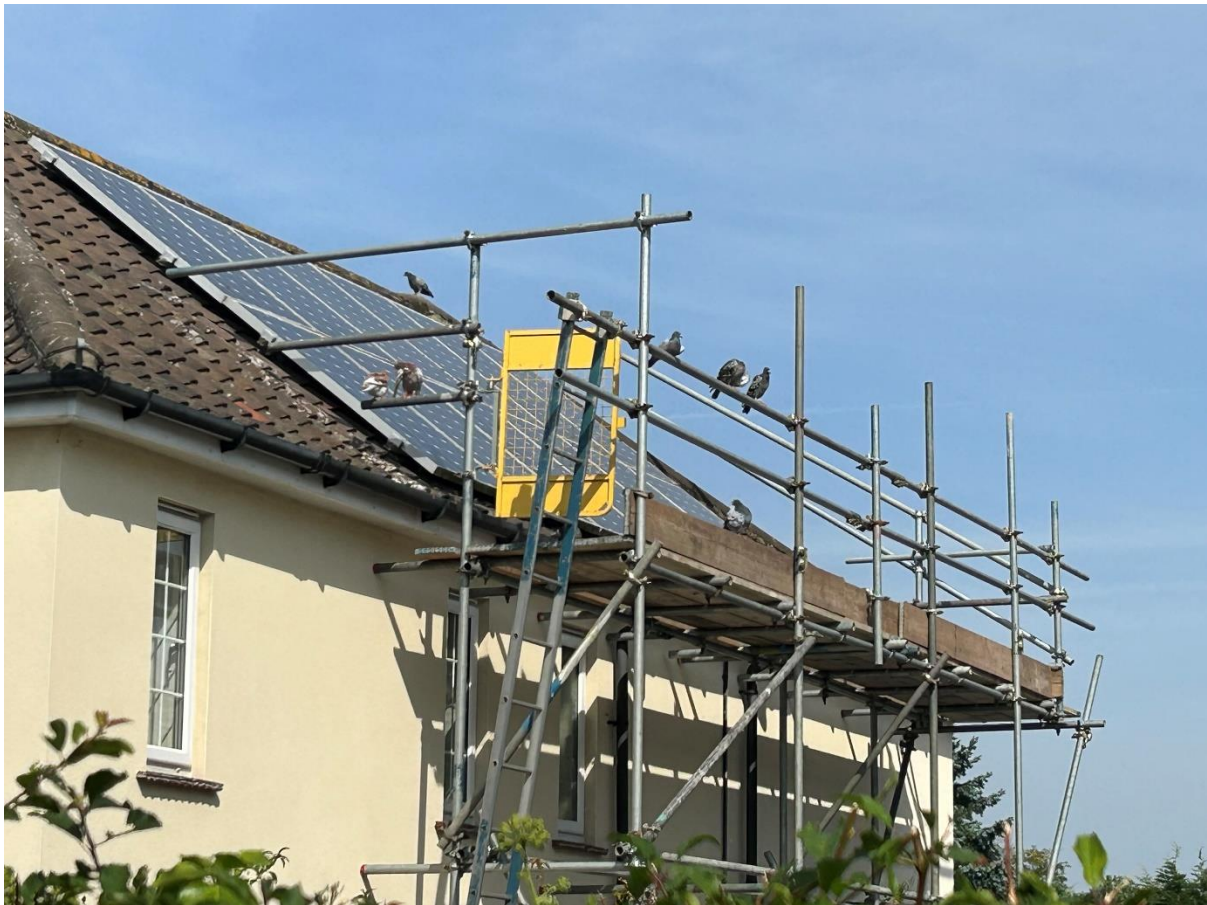
With this particular property, neither a scaffold tower nor a cherry picker would have sufficient space, hence scaffolding was erected up to the gutter line to provide a safe working platform.

You can see the pigeons immediately decided this gave them a great place to roost.

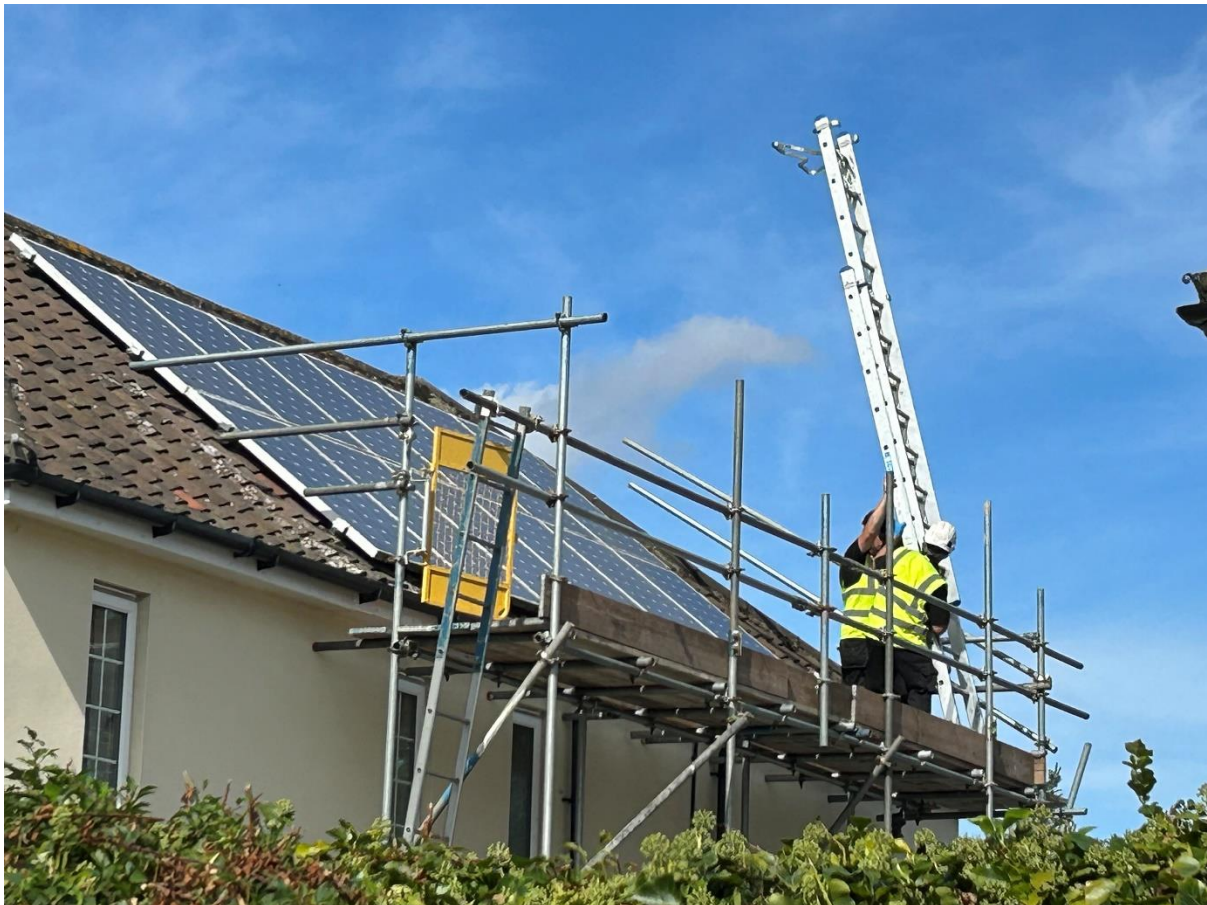
They raised a ladder onto the scaffolding using a rope pulley system. This ladder was secured and after fitting a push-off at the top of the ladder, this was gently lowered over the panels and onto the roof above the top panel.

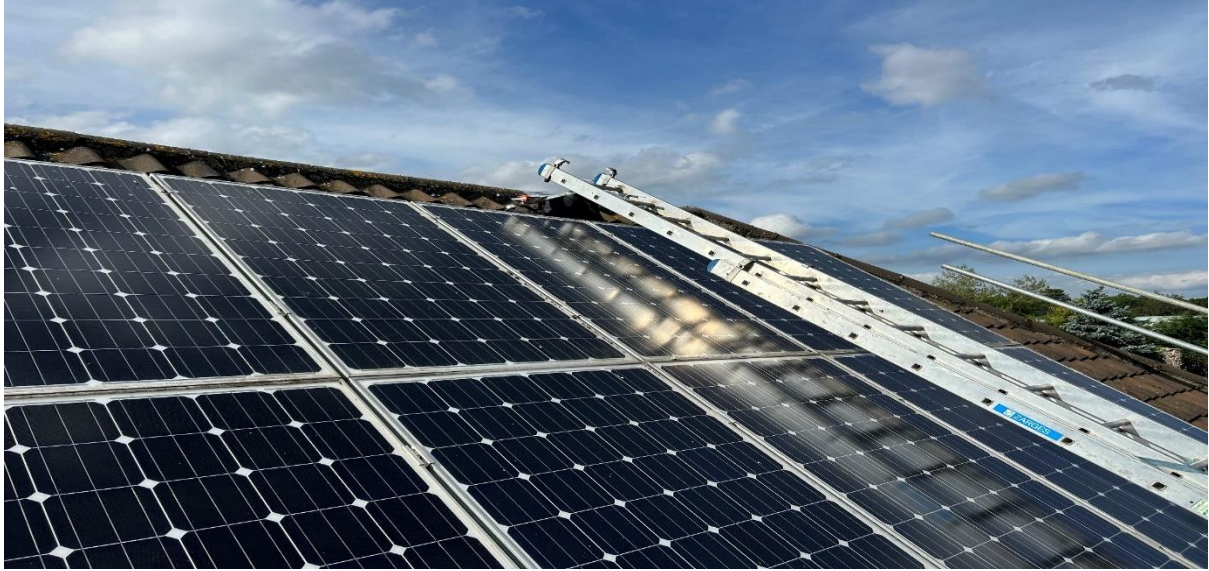
This provided a safe, secure platform to work off, without touching the surface of any of the solar panels.

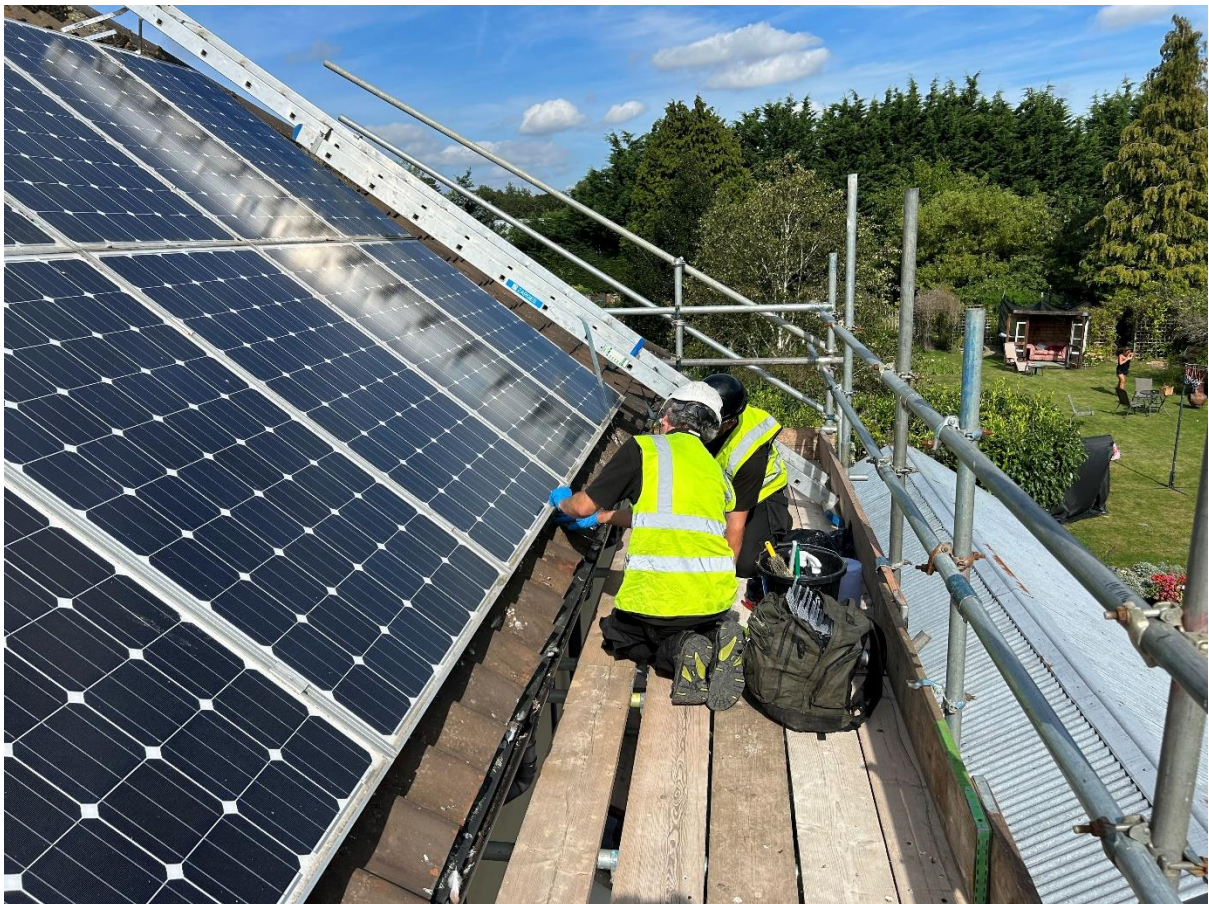
The edges of all the panels were cleaned using biocide, to not only sterilise the area, but by having clean edges on each panel, this ensures a good surface for the adhesive that will be applied to each strip of plastic proofing. A clean surface makes for a very strong bond once this is applied.

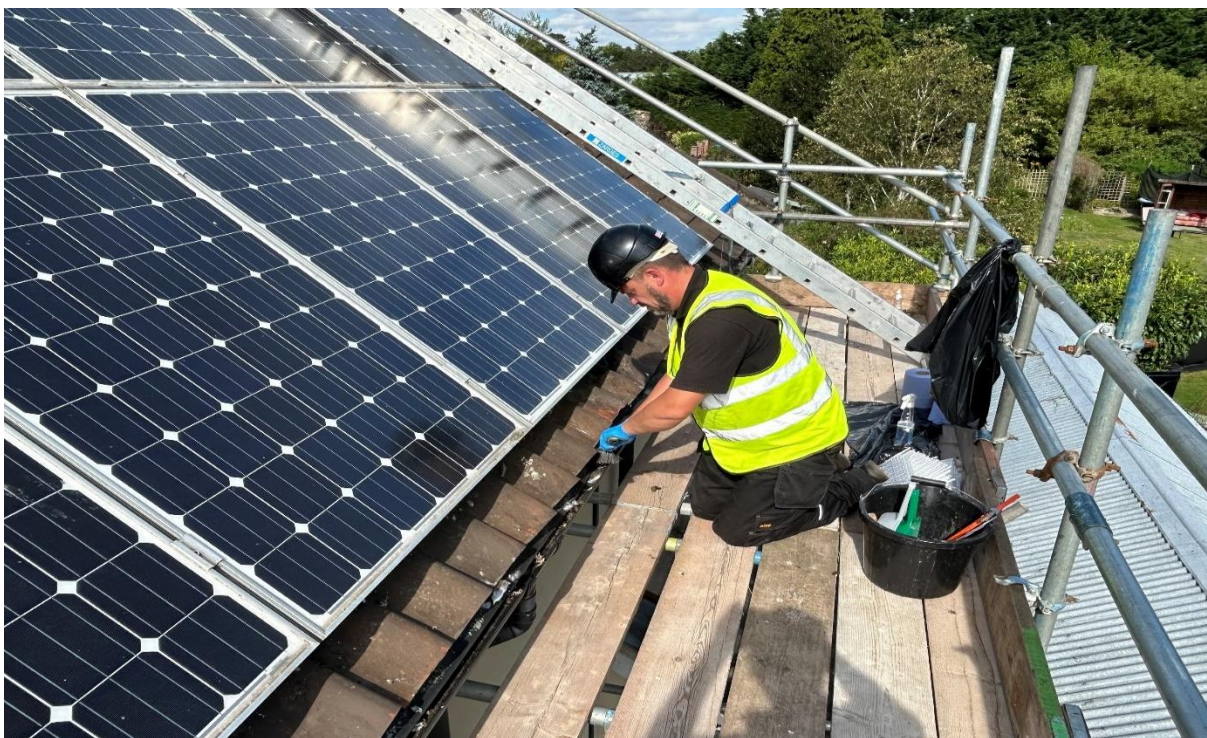
In this case, one substantial old nest was located near the bottom left hand edge which was totally removed and the area cleaned thoroughly. The nest itself was extremely dirty, with numerous maggots and other parasites clearly visible.

Any bird nesting material we can reach will be removed and bagged up too – being mindful that we mustn't disturb any wires or other electrical areas underneath the panels.
